# Brittle Fracture Failures at Israel Electric: Study & Analysis

The following article was contributed by Messrs. F. Kaidanov, R. Munteanu, G. Sheinfain of the Electrical R&D Laboratory at Israel Electric

## 1. Background

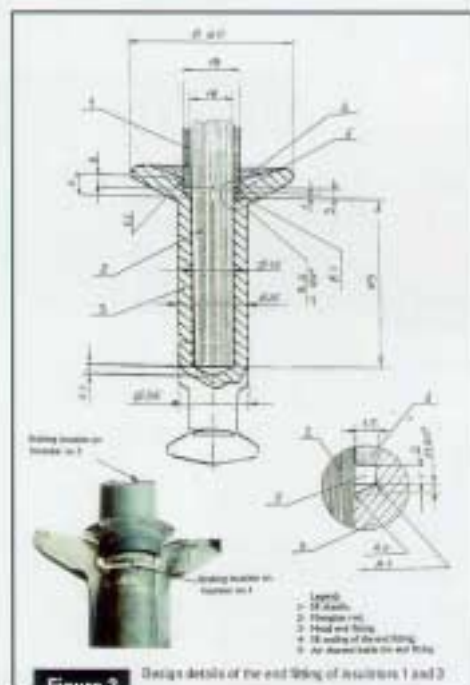
Figure 3 Design details of the end fitting of insulators 1 and 2

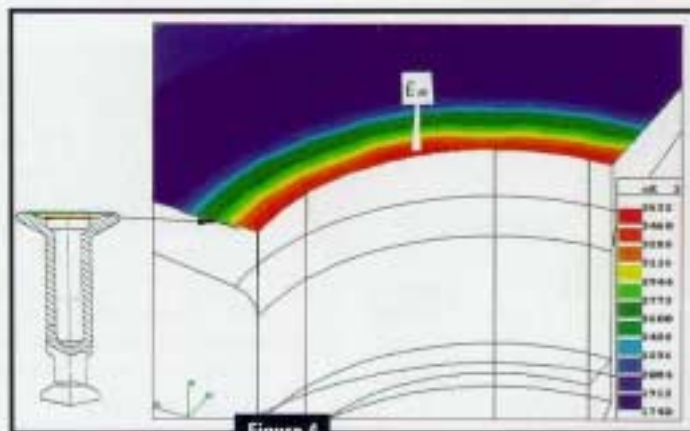
Figure 4

The area under maximum electrical stress was located near the silicone rubber sealing layer at the arc control lip. (These results are presented in Figure 4). The maximum value calculated for this area was 36 kV/cm.

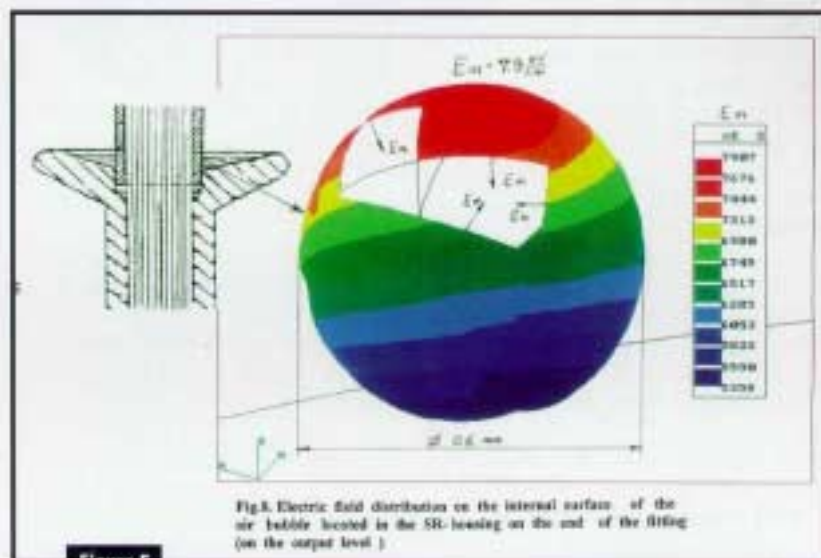
Figure 5

For a crack 1 mm wide on the silicone rubber housing, covered with thin, very wet, conductive contamination and located close to the end fitting, the maximum electric field was some tens of a kV/cm. For an air bubble with a 0.6 mm diameter, the maximum electric field was 8 kV/cm (see Figure 5). The discharge locations on the surface of those insulators observed during the field trips under operational conditions matched the maximum electric field distribution calculated in the computer model.

Fig.5. Electric field distribution on the internal surface of the air bubble located in the SR-housing on the end of the fitting (on the output level)

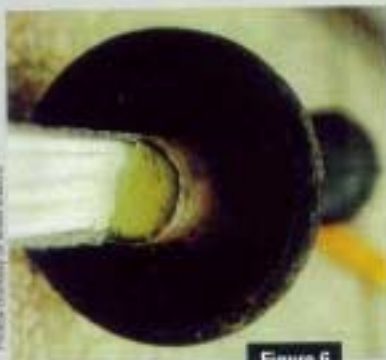
Figure 6

The three insulators which had failed were taken to the laboratory for investigation (two of these are shown in Figures 6 & 7). These insulators were 6-7 years old and had been used on the line for between 1.5 and 6 years.

- For all three insulators, the silicone rubber housing was found to be 1.5 mm thick.
- All three insulators were identical in structure.
- In all three cases, the brittle fracture failure occurred in the area between the end fitting

close to the conductor and the first shed of the insulator.

- In the vicinity of the failure, accelerated wear of the insulator housing was recorded, apparently caused by electrical activity (discharges).
- Signs of mechanically-induced damage were recorded in this area (insulators 1 and 3).
- The silicone rubber material which seals the opening to the end fitting was found to be burnt and partially peeled by electrical activity including discharges and the appearance of corona (see Figure 8).
- Two distinct areas were visible on the fracture surface: one perpendicular to the insulator axis, and the other (about 15% of the rod fracture surface area) having the appearance of a standard fracture which results from tensile stress.

- The width of sheath required in specifications for composite insulators is now defined as "at least 3 mm"
- Composite insulators for 161 kV are specified to be supplied with grading rings on the line end and must pass a corona test.
- Storage and line personnel receive special instructions for proper handling of composite insulators.

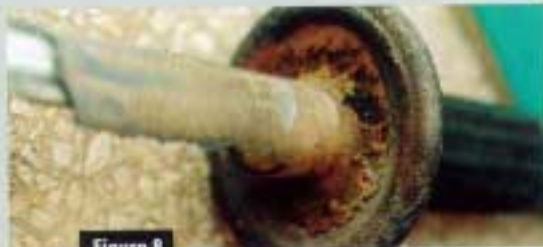
Figure 8

On each of the three failed insulators, on some areas the cross-section of glass fibers is clearly visible and their surface is smooth as typical of a brittle fracture.
